Oversight News

Newsletter of the Commonwealth's Environmental Oversight of the Paducah Gaseous Diffusion Plant

Installation of Six-Phase Heating System Begins

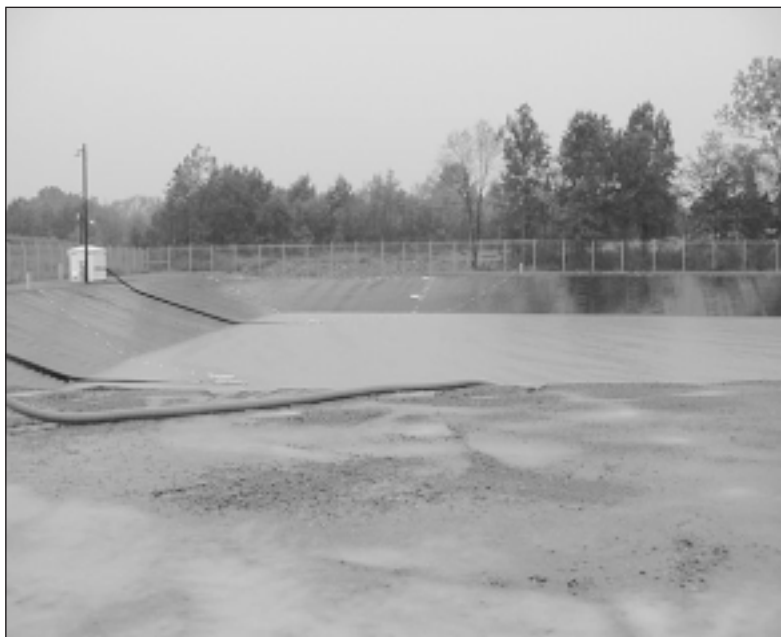
The new storm water collection basin is in operation in the north-west corner of the Paducah Gaseous Diffusion Plant property. The basin collects rainfall that runs off scrap metal yards in the area and picks up potentially contaminated sediments. By allowing the sediments to settle out of the storm water, the basin limits the flow of contaminants into Bayou Creek nearby.
